EQUIPMENT CONDITION INVENTORY	
BUILDING ASSESSMENT	
D.C. DEPARTMENT OF GENERAL SERVICES	
LINCOLN THEATRE 1215 U STREET, N.W. WASHINGTON, DC PO388329	
TYPE OF EQUIPMENT	: Main Switchboard
LOCATION	: Basement Electrical Room
IDENTIFICATION NO.	: MSB
MANUFACTURER	: General Electric
NO. OF CUBICLES	: 7 Sections
EQUIPMENT CONDITION CODE <small>RED: Poor condition. Severe deterioration. YELLOW: Marginal condition. Moderate deterioration. GREEN: Acceptable condition. Limited deterioration.</small>	
CODE	: Green
AGE (YRS)	: 20 years
TYPICAL USEFUL LIFE (YRS)	: 50 years
REMARKS : Ammeter not functioning. GE#72298872; Plant # T222 Inspected by Kolb Electric 4/5/04

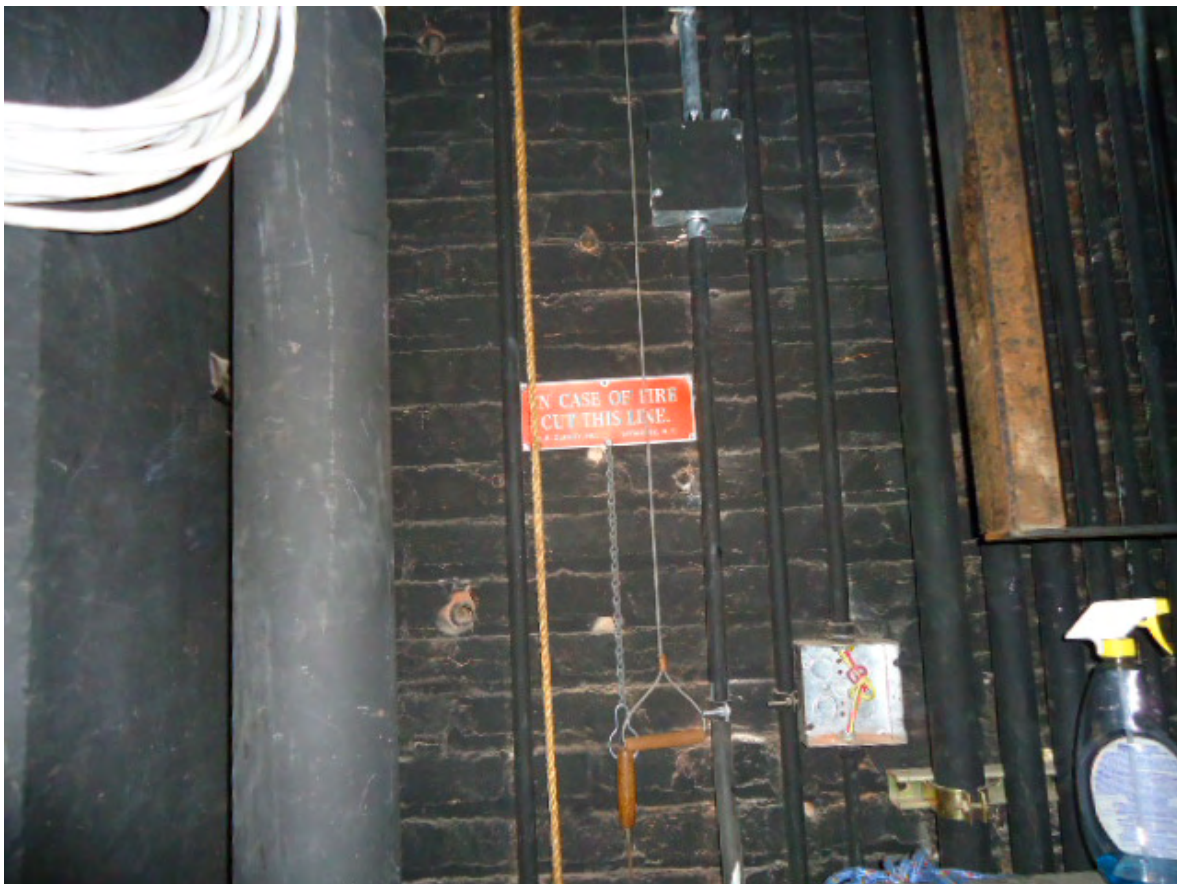
Unable to determine if the roof vents above the stage are in working condition. Unable to tell if they are connected to heat detectors and Fire Alarm Control Panel. Unable to determine if manual release is in working condition.

Perform tests to determine if existing roof vents are in acceptable condition. Determine if vent openings are tied to heat detectors and Fire Alarm Control Panel. Determine if roof vents can be manually opened with existing release ropes. Repair all release mechanisms and controls determined to be inadequate.

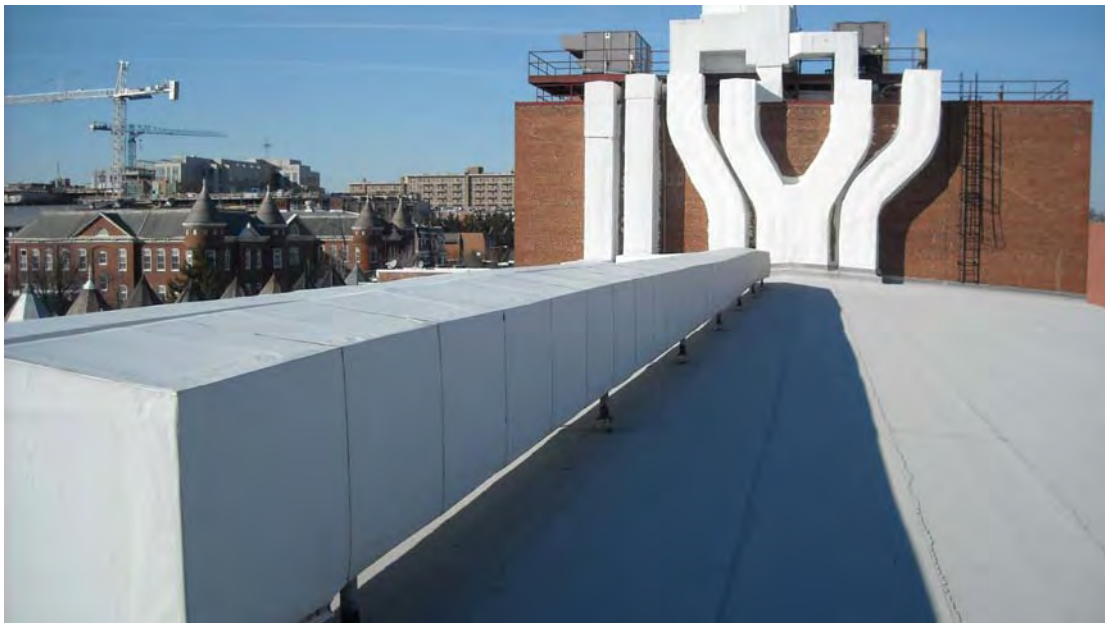
Unable to determine if smoke level will stay 6' above highest seat or if more ventilation will be required.

Determine if RTU-1 can and needs to be programmed to a purge setting and could be used for further smoke control solutions. Provide new RTU with a purge setting to ensure adequate height of potential smoke layers.

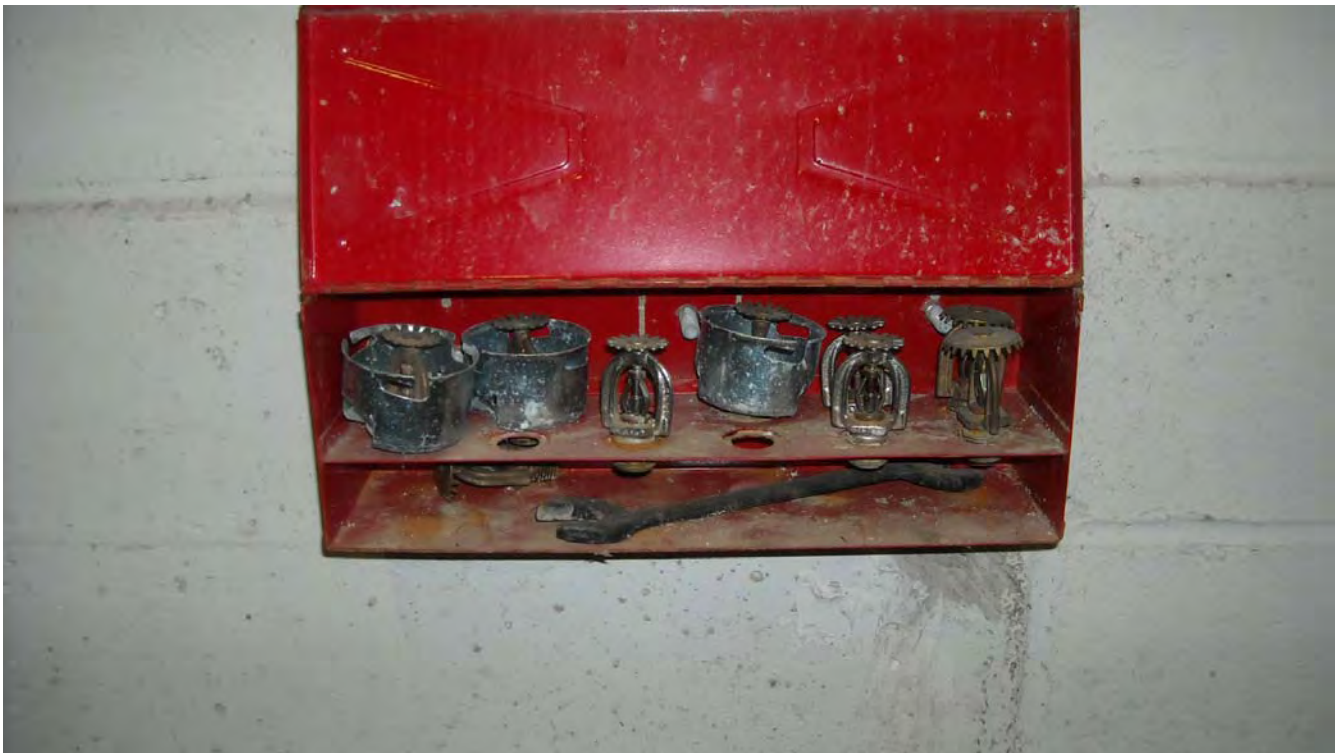
The current stock of spare sprinklers is inadequate. List of current installed sprinklers is missing from inside cabinet.

Replace stock of spare sprinklers with an adequate amount and make sure they match the existing installed sprinklers. Provide sprinklers for each kind of sprinkler currently installed and include a detailed list of the types.

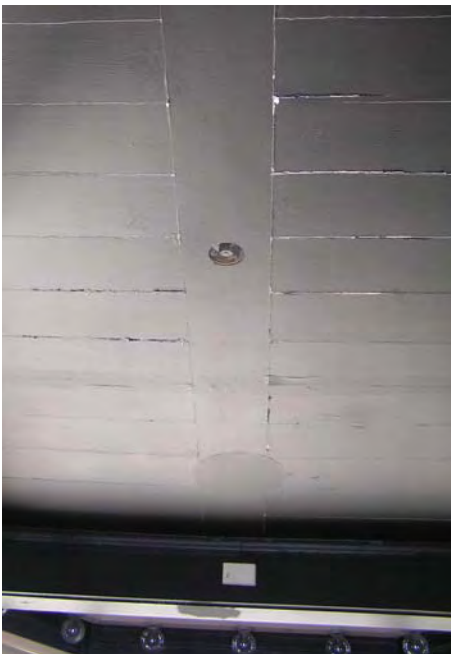
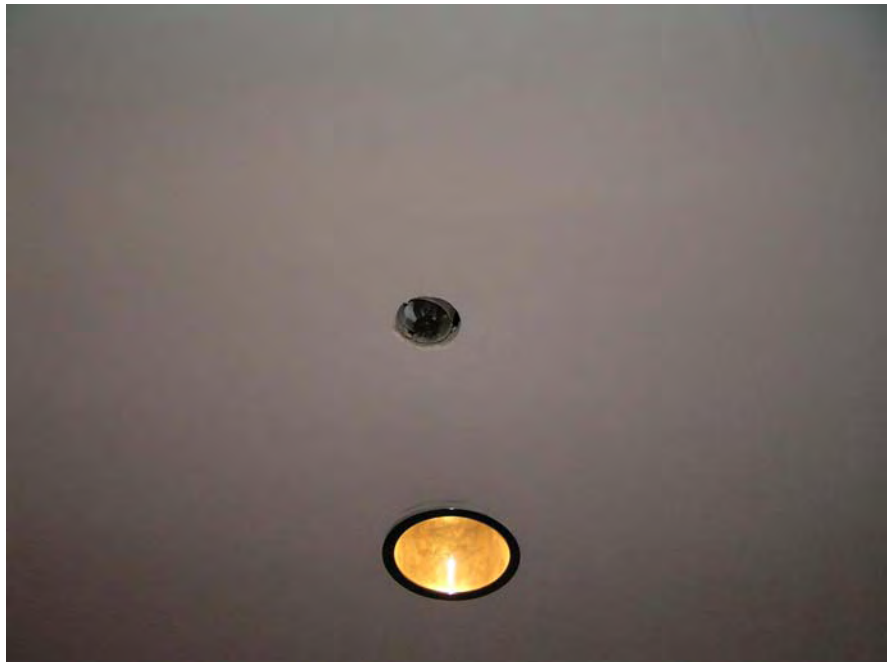
Multiple sprinkler heads are missing their covers.

Replace sprinkler head cover plates in kind.

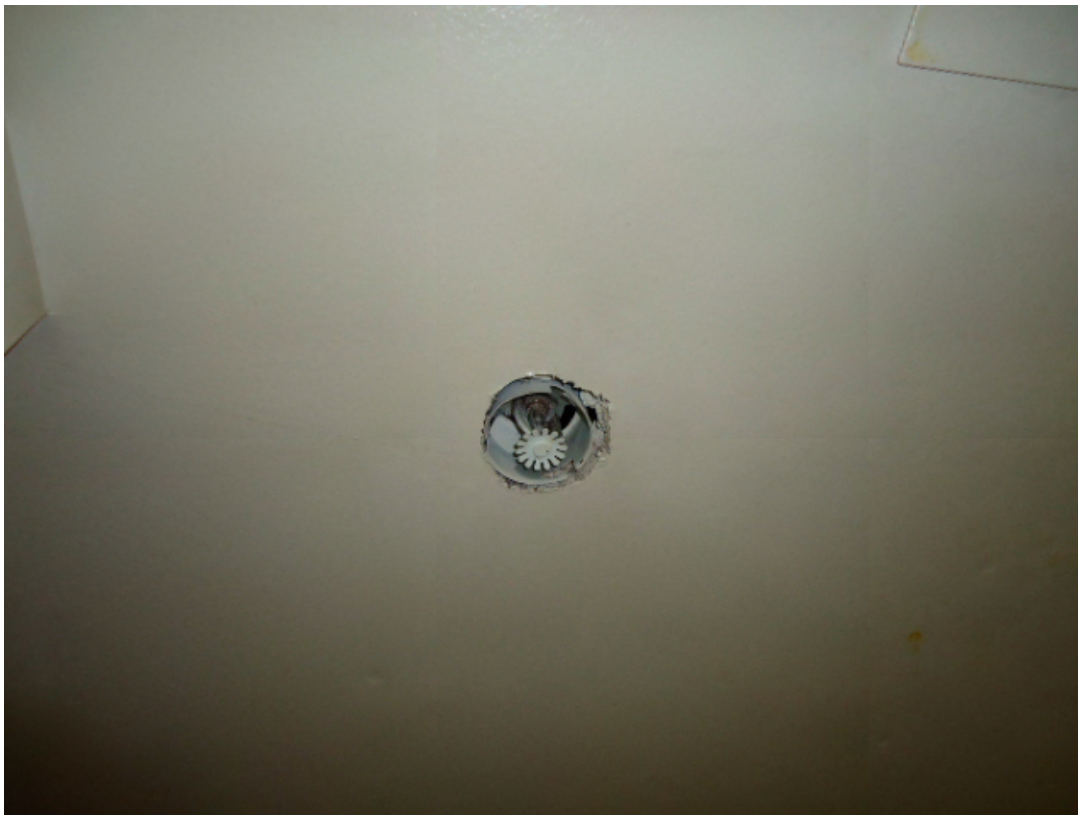
Multiple sprinkler heads have been painted over.

Replace painted sprinkler heads in kind.

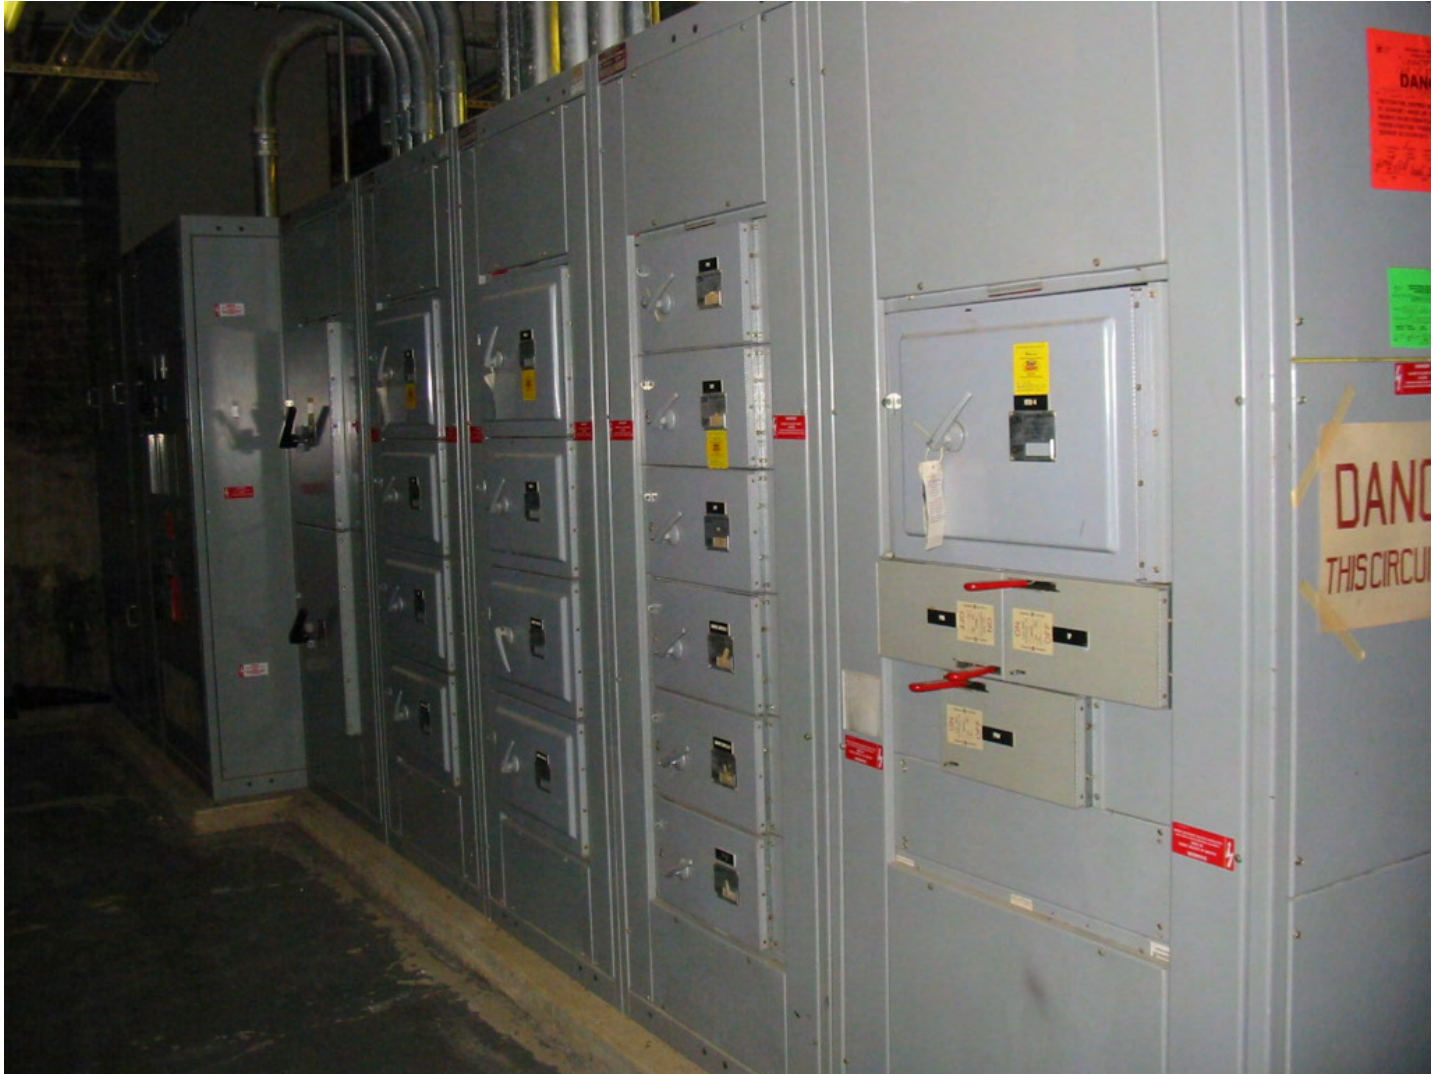
Main switchboard showing incoming section, main section and distribution sections.

Each section will require voltage and current metering during an event. The documentation from the metering will be analyzed to determine probable cause of the voltage fluctuations. The solution would be isolate the problematic circuit or provide a power conditioning system that will provide a regulated voltage regardless of external forces.

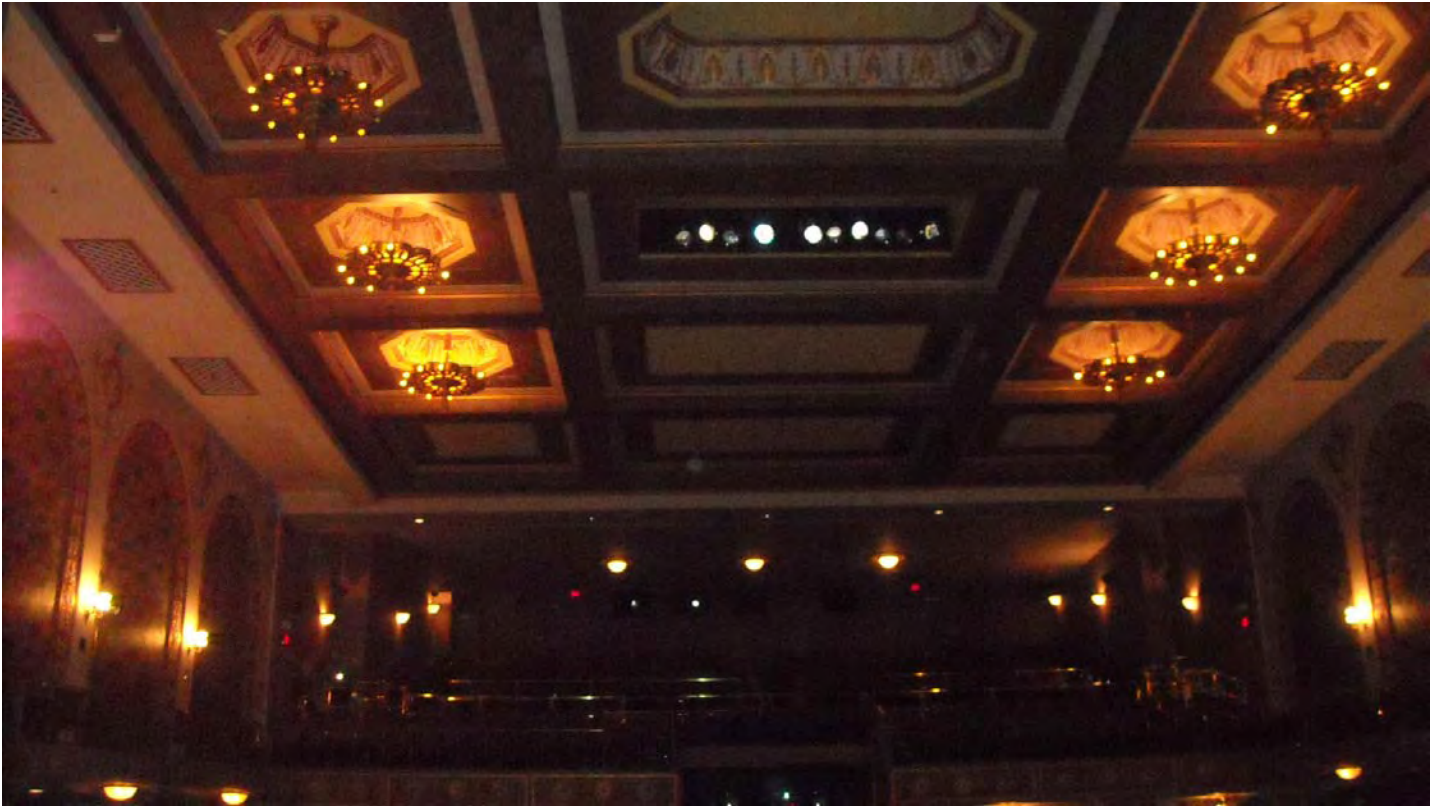
Typical incandescent lighting found throughout the facility.

Incandescent lighting is extremely susceptible to voltage fluctuations.

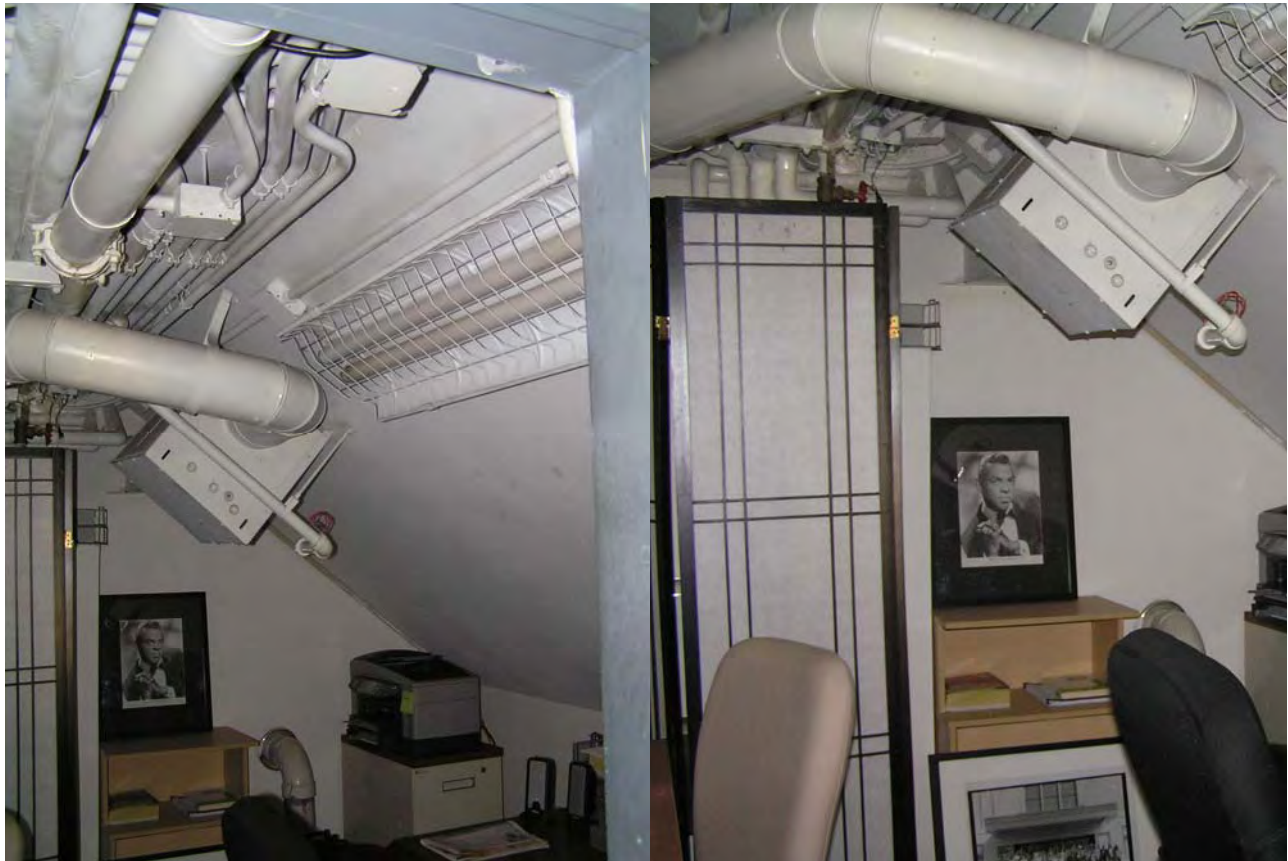
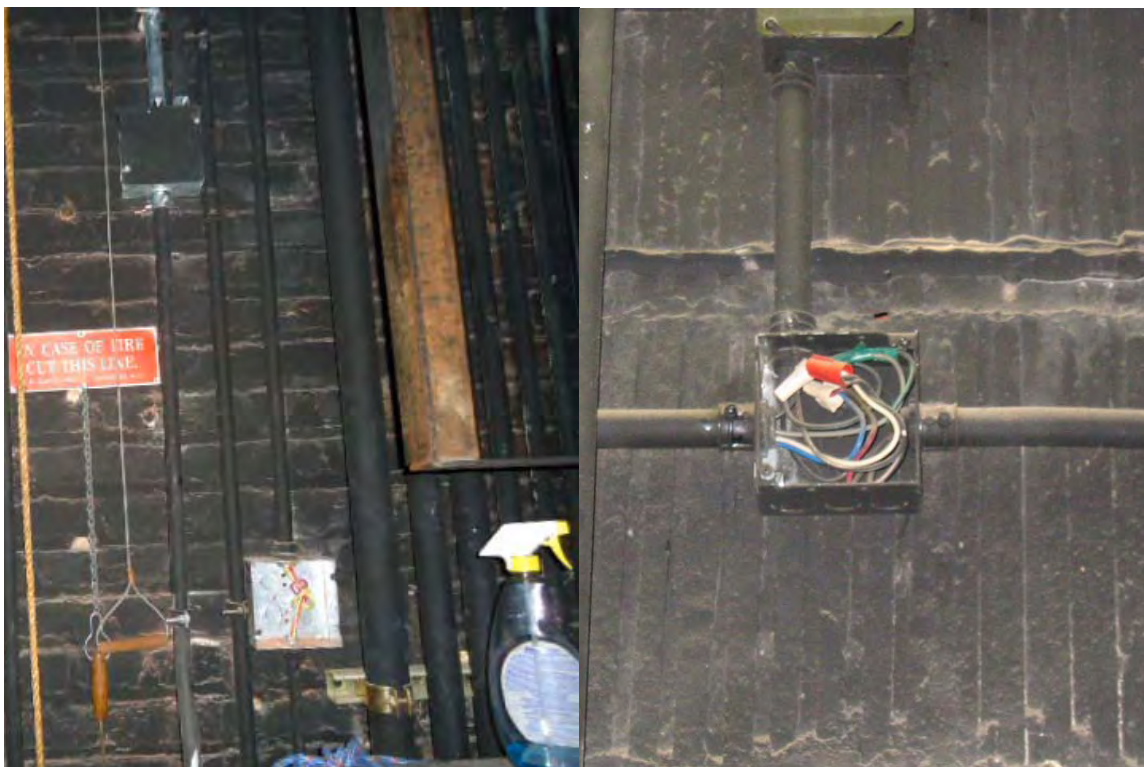
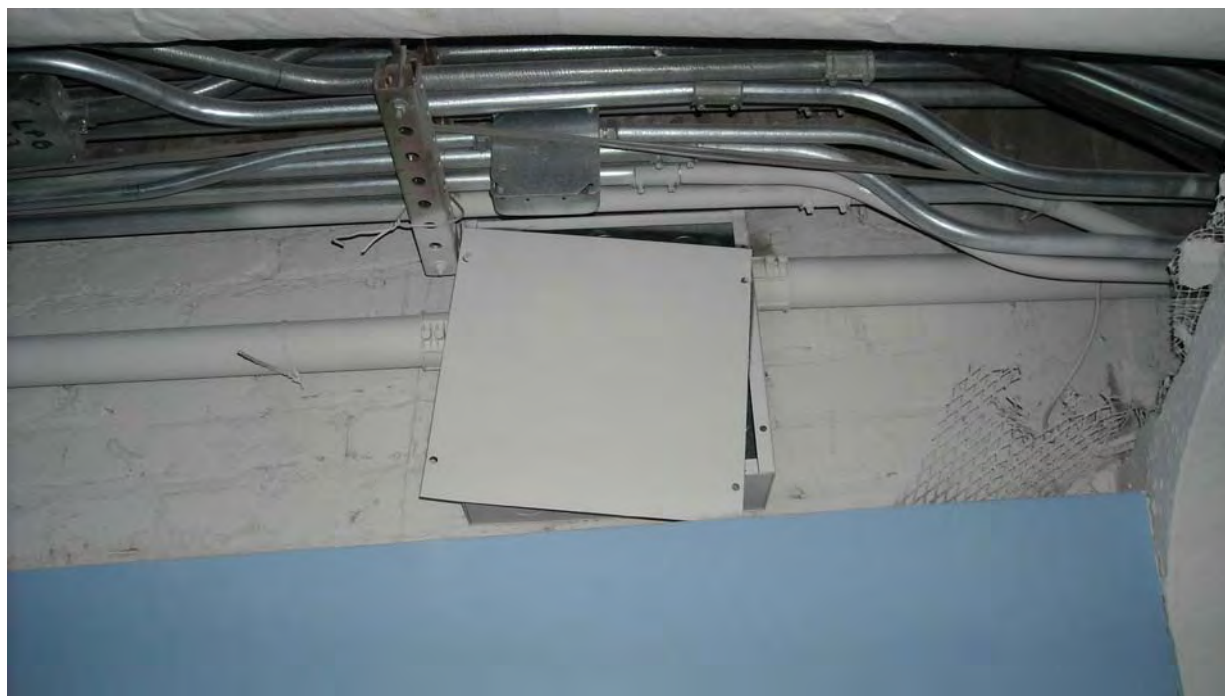
Open or unsecured junction boxes with exposed wiring.

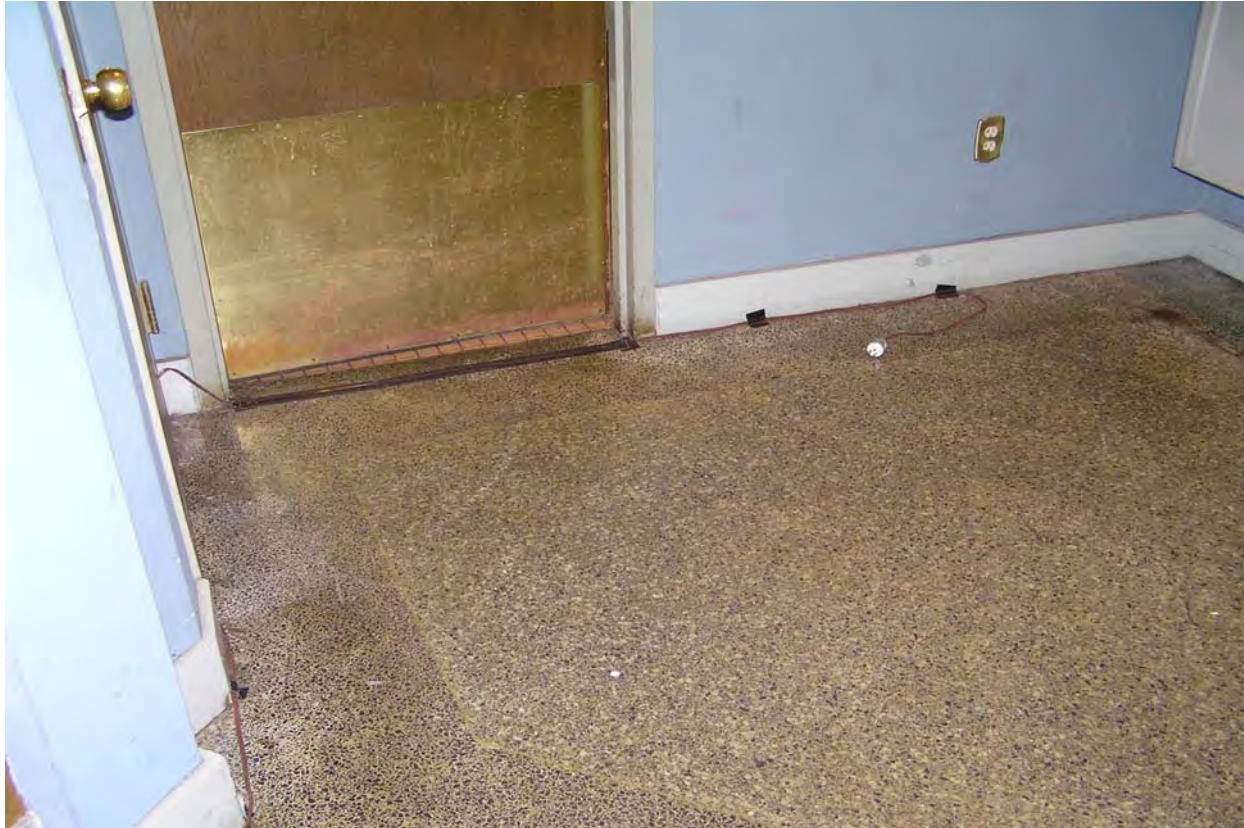
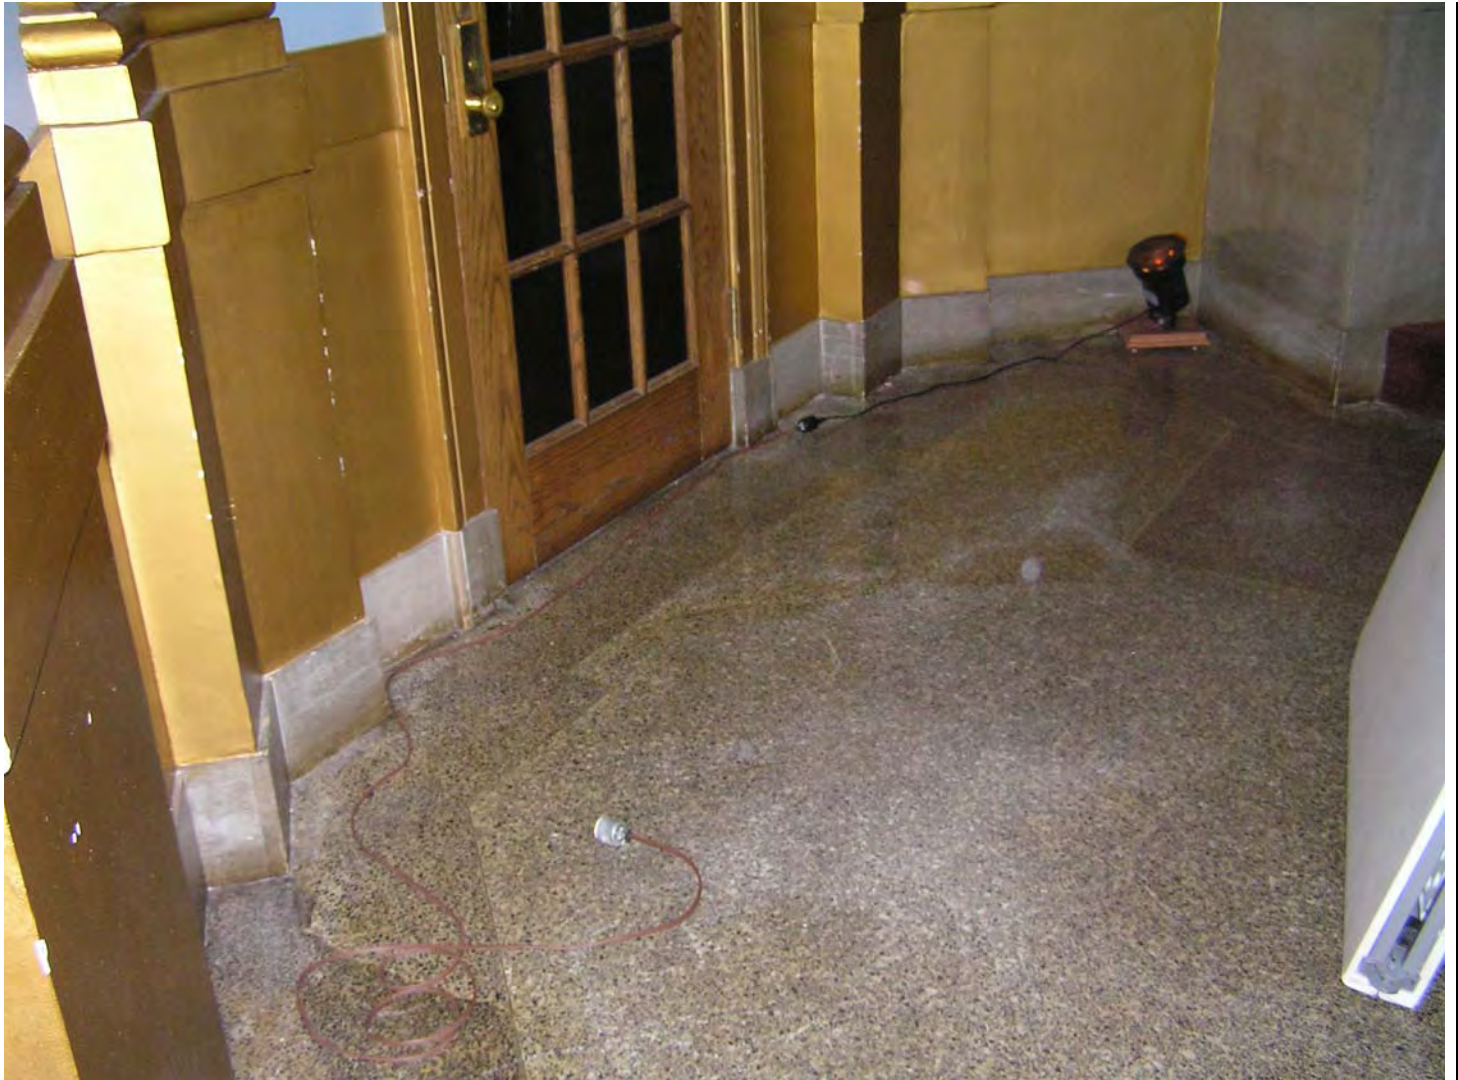
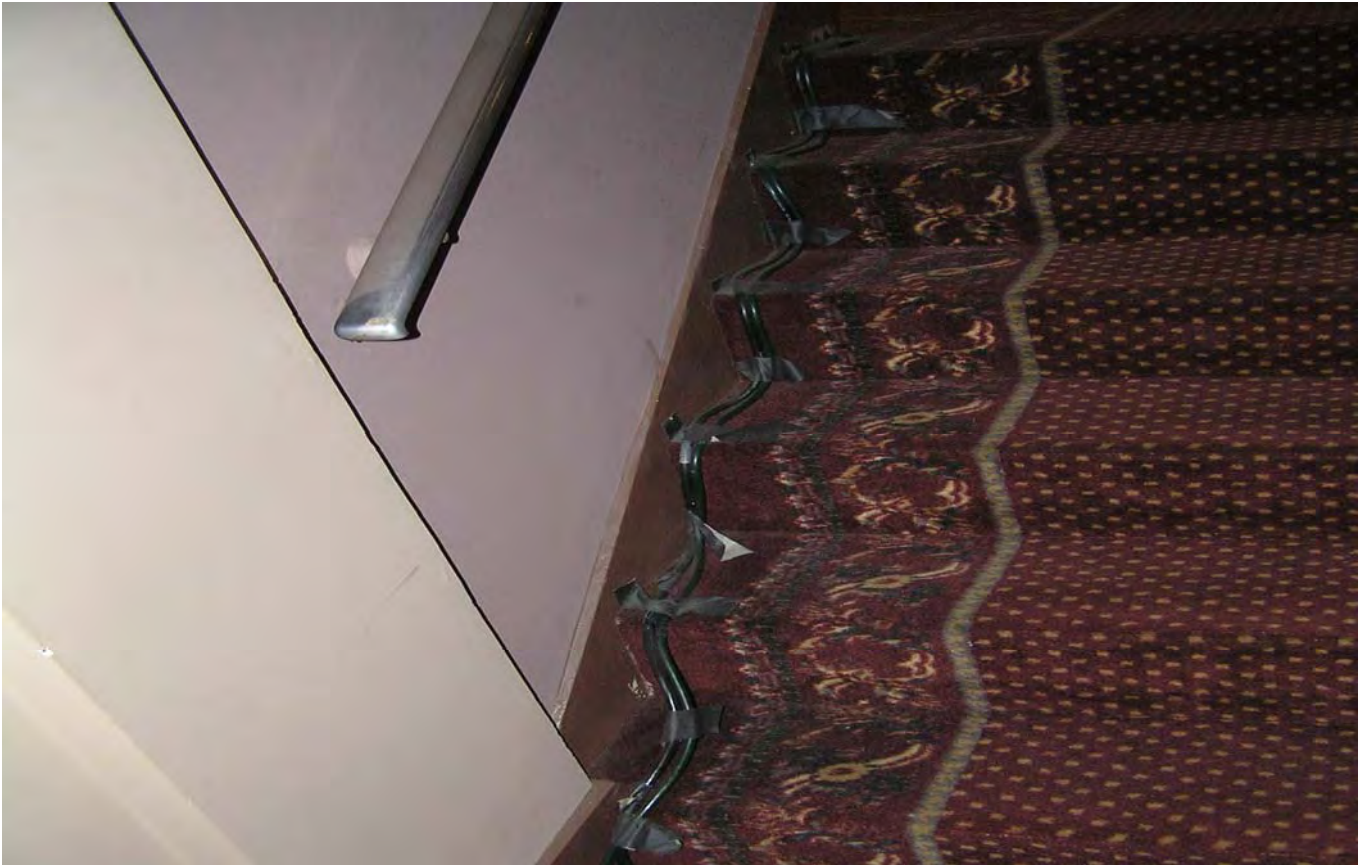
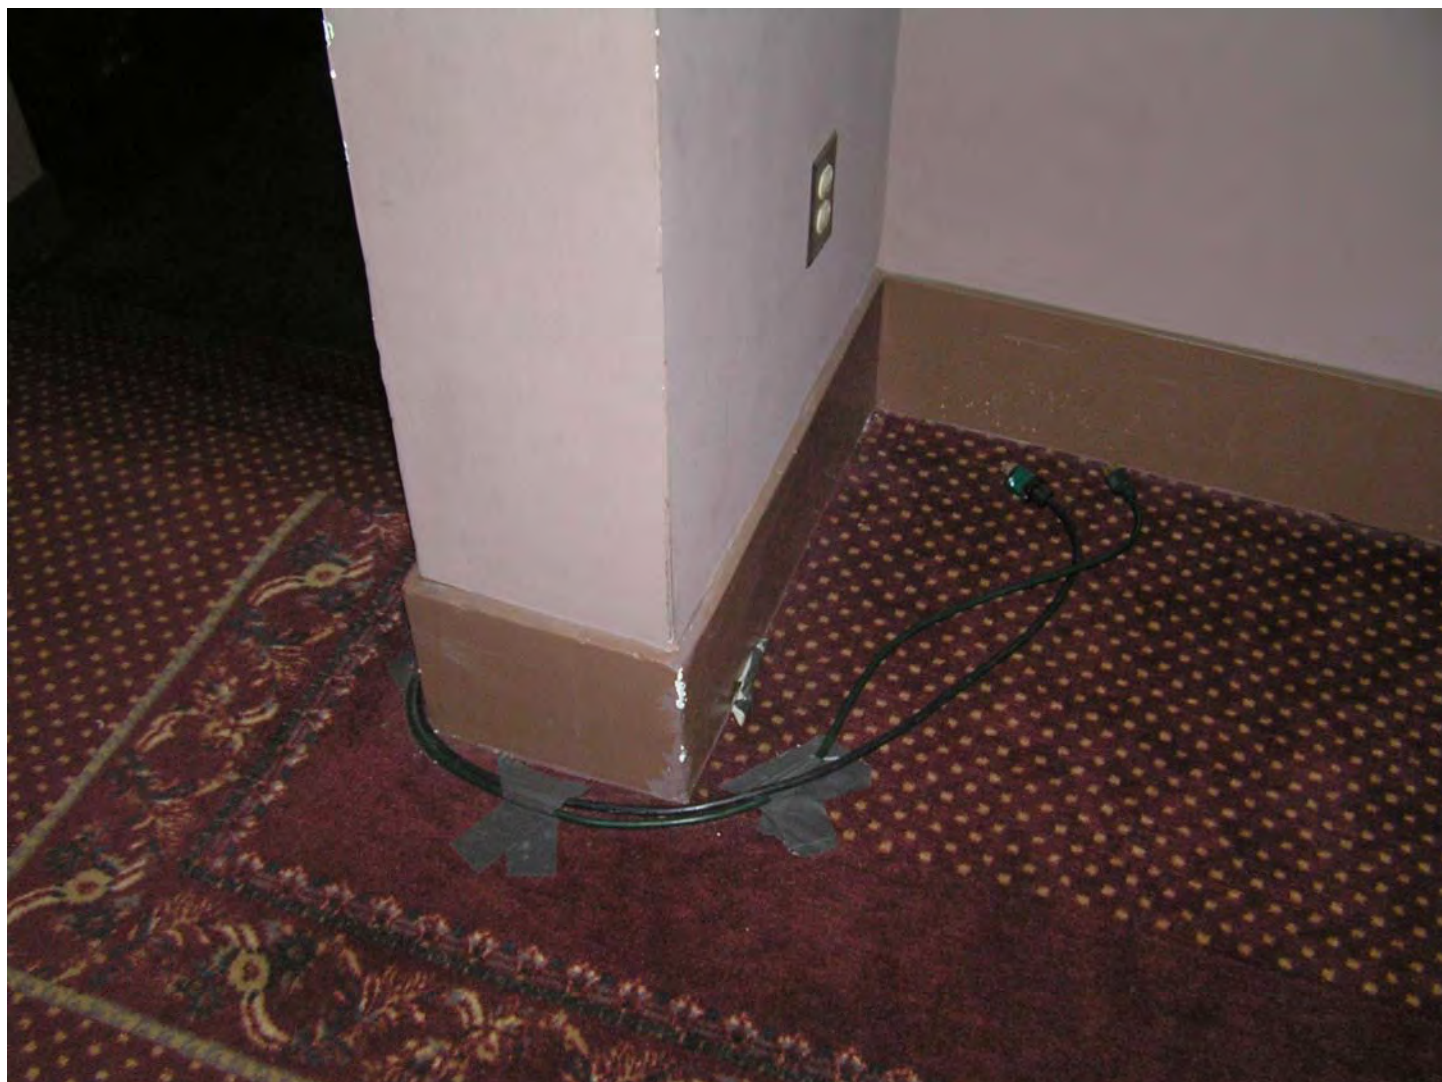
Appliance cord routed along floor in public area.

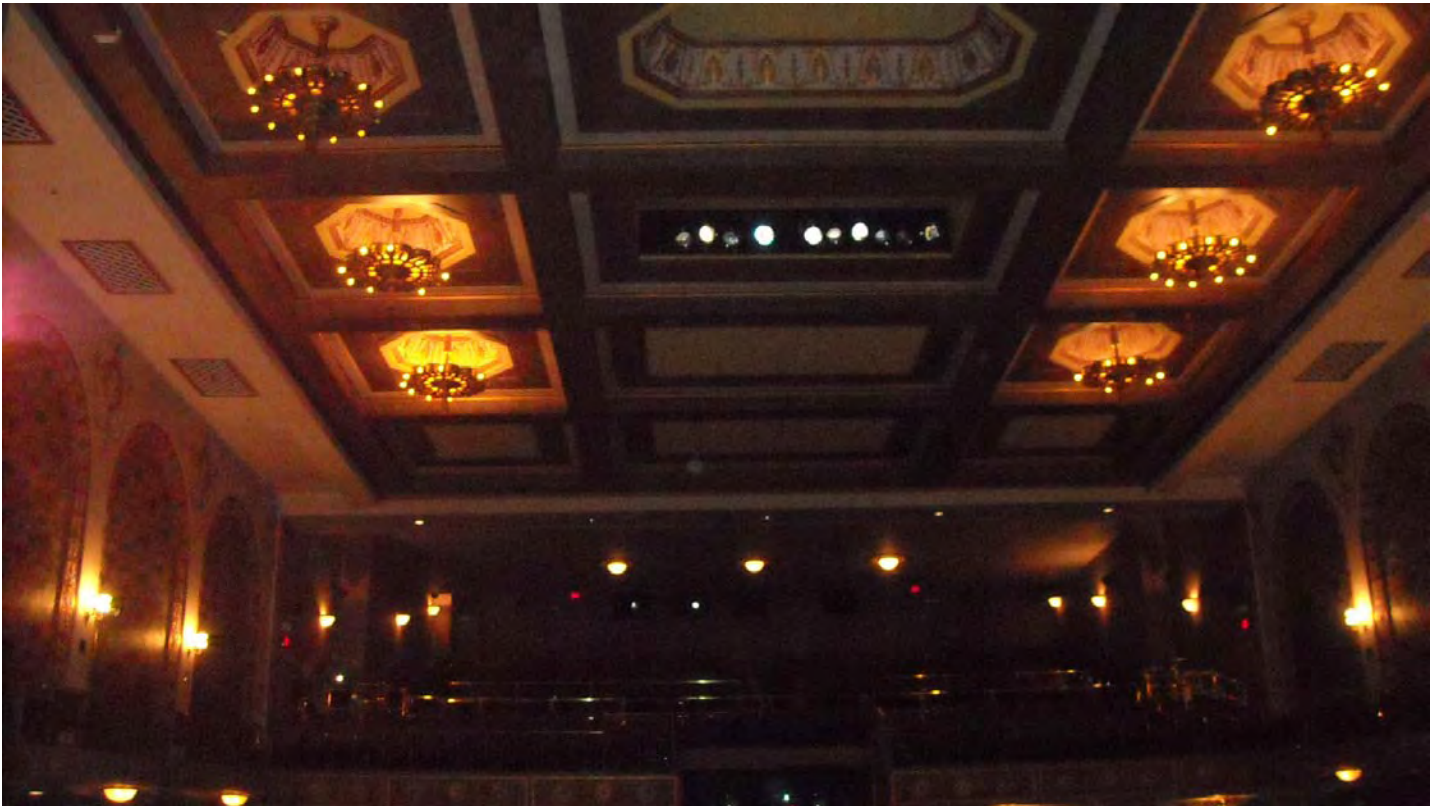
Historic lighting fixtures showing burned out lamps.

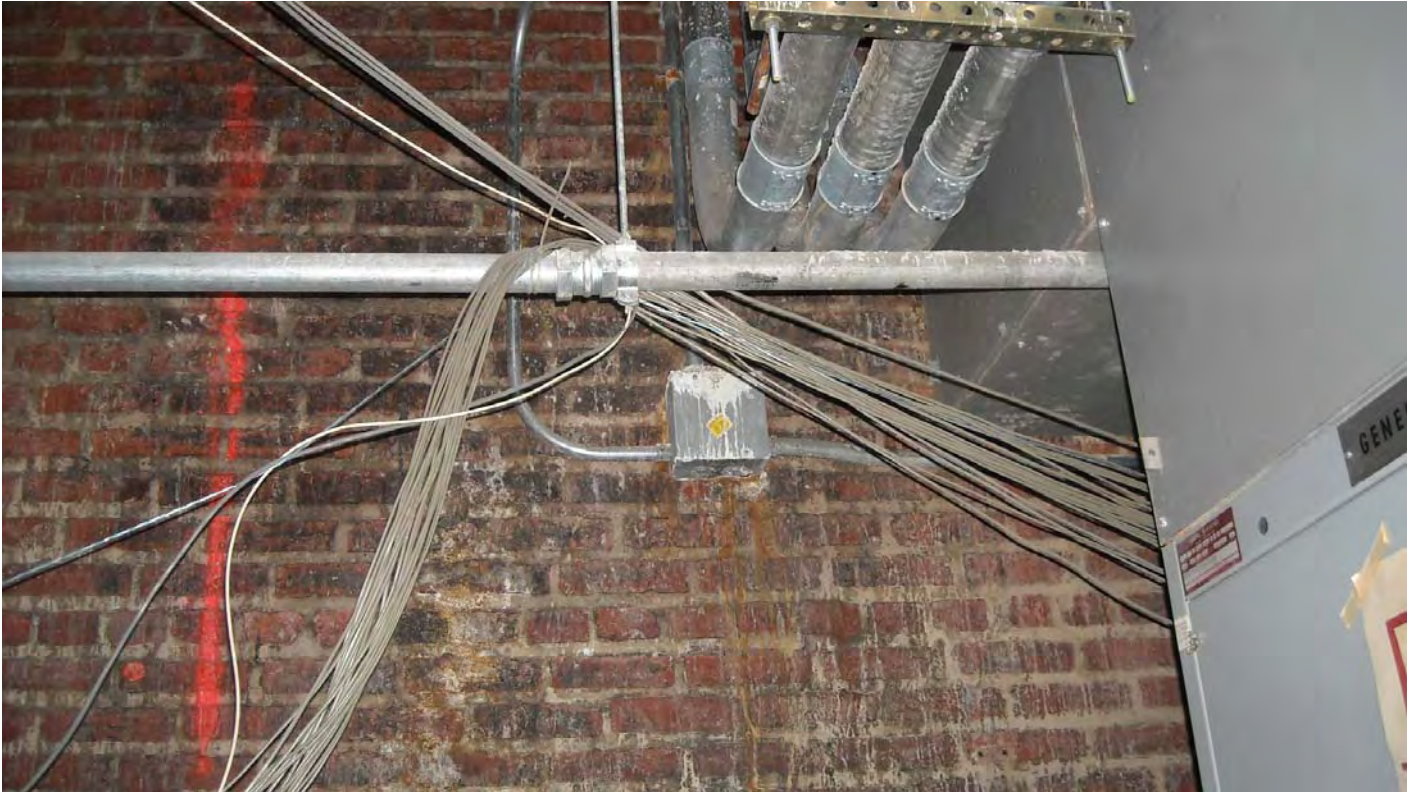
Improperly supported cables.

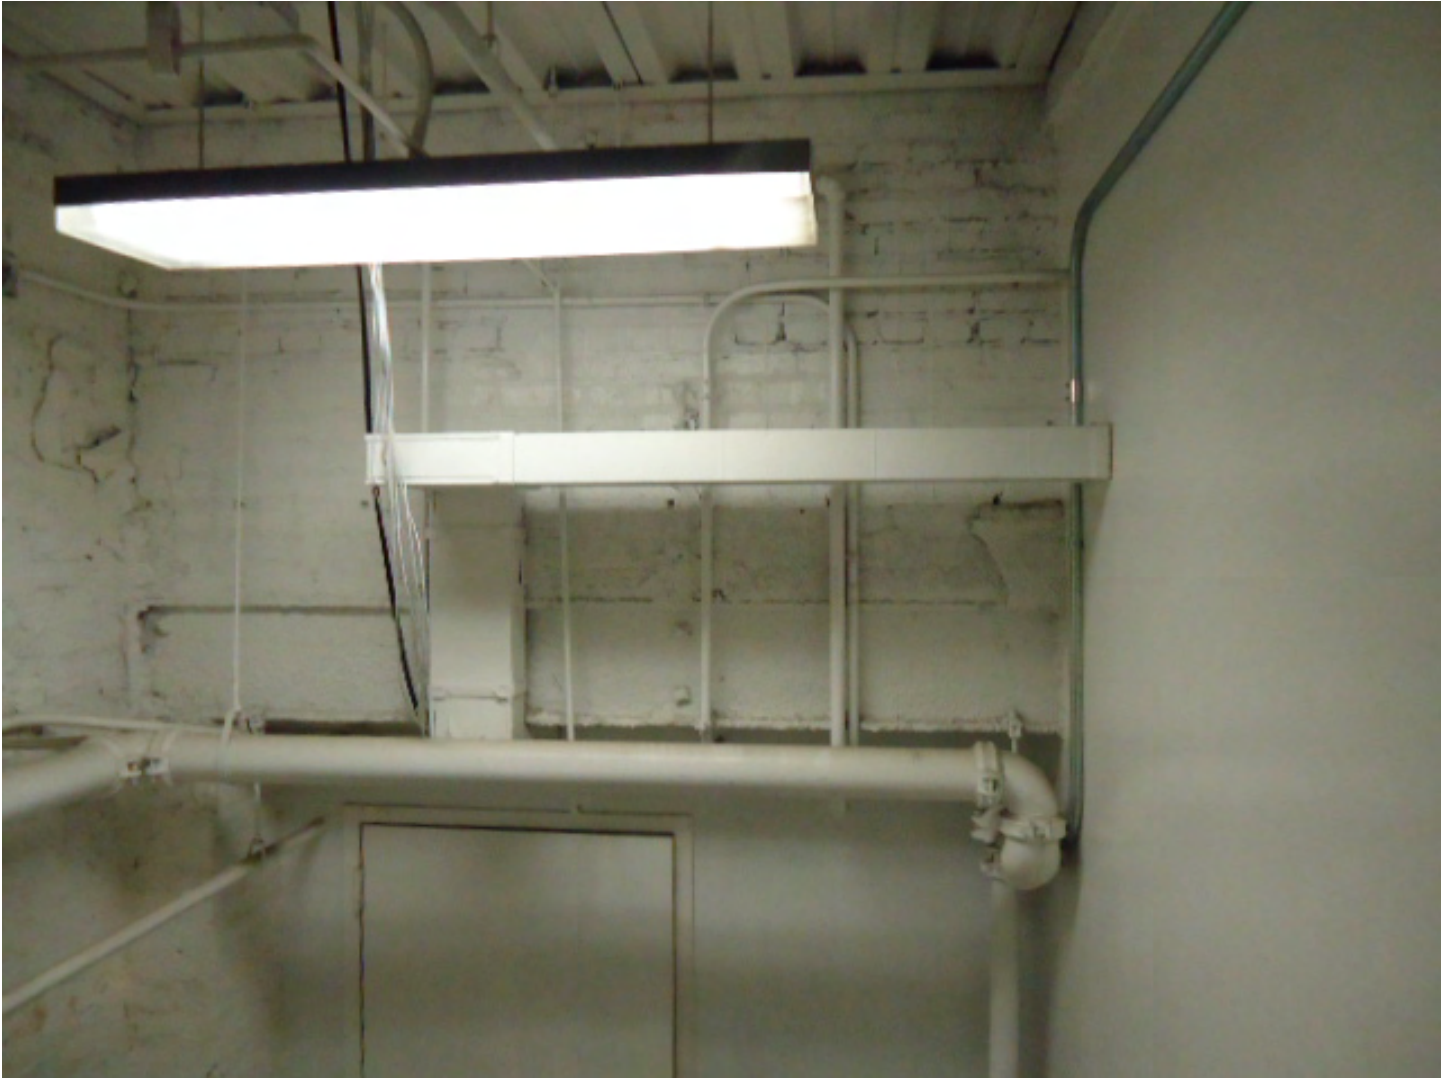
Improperly supported cables.

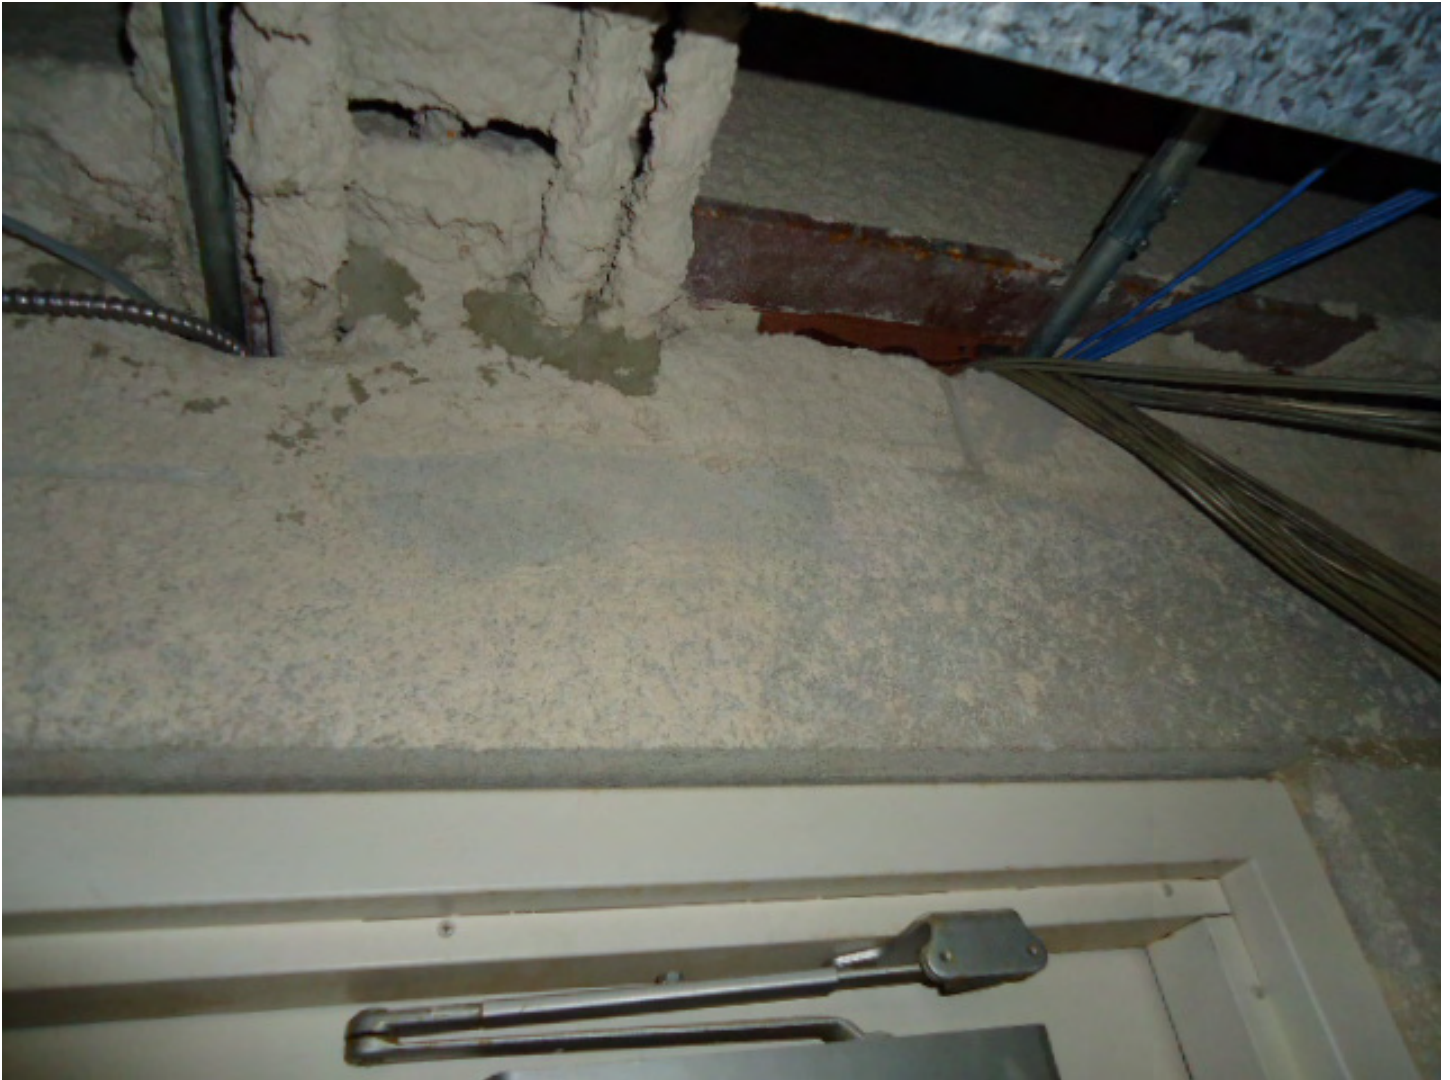
Improperly supported cables with no fire stop.

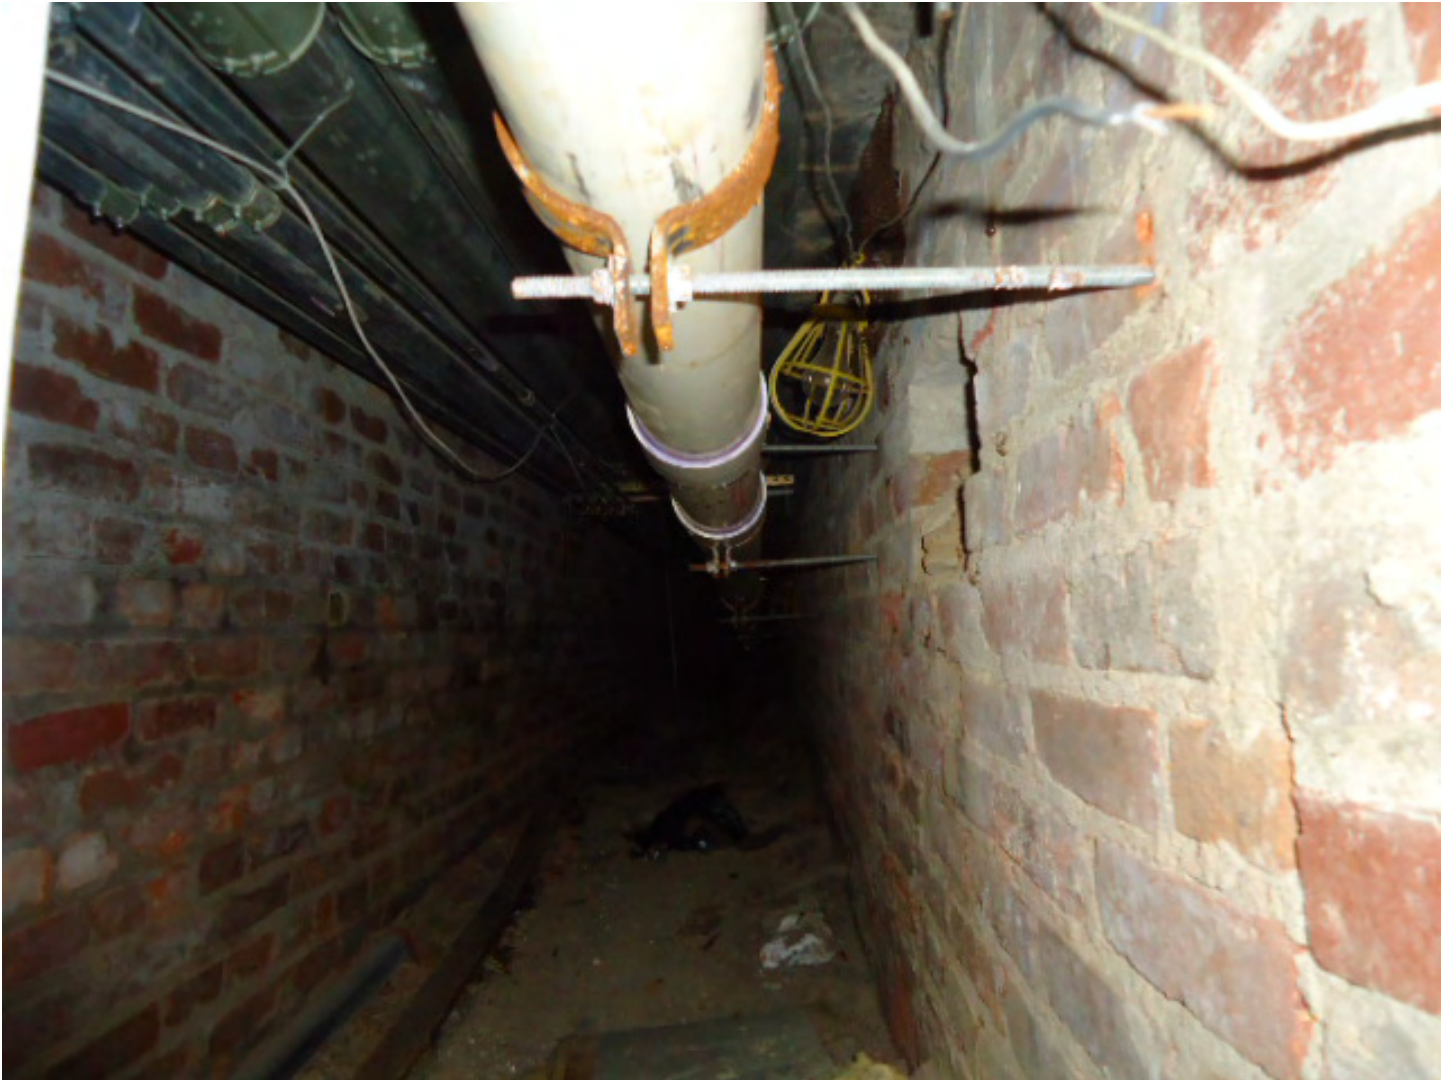
Improperly supported cables.
